# Pequannock Township

## **Environmental Resource Inventory**

July 20, 2009

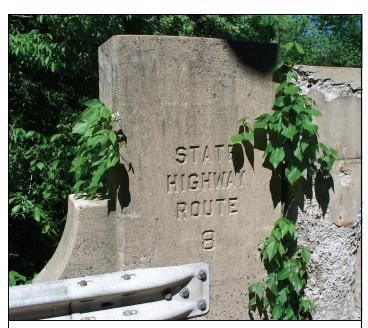
Figure 3-1: Bridge On Newark Pompton Turnpike In Pequannock Shows Relic Of State Highway 8

State took over the Turnpike and numbered the newly paved road State Highway #8 (see Figure 3-1). In 1922, it was renumbered N.J. Highway 23 and paved with concrete from the bridge into Pequannock to Richard's corner in Riverdale. It reverted to a local county road when Route 23 was relocated to the east of the Turnpike in 1935.

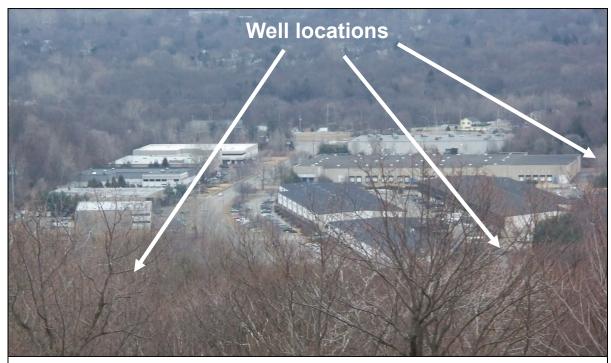
Figure 5-3: Area Around Municipal Wells of Pequannock Township (looking east)

As shown in the aerial view in Figure 5-2, there are extensive roads and parking lots, including Rt. 287, in the area of Pequannock's wells. The Malcolm Pirnie report, published in 1980, discussed the potential influence of Rt. 287 on these wells. The report stated that "A preliminary study conducted by the New Jersey Department of Transportation (N.J. DOT) suggests that the major source of possible contamination is from salts used in highway deicing operations. These include sodium chloride and calcium chloride. "Although the N.J. DOT concluded that "...contamination of any water resources, either ground or surface waters, in the vicinity of the proposed highway would not occur."

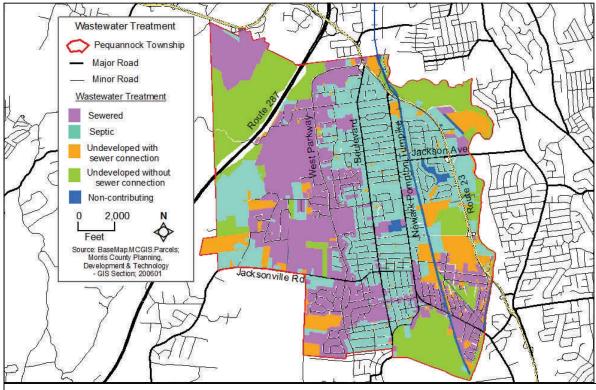
Figure 5-4: Wastewater Treatment in Pequannock Township

Conditions in certain sections of Pequannock are not suitable for conventional septic systems. Pequannock's Master Plan has designated certain sections of town to remain on septic, with other areas to become sewered. In 2008, the township completed two sewer-service expansions, one in the southeastern Pequannock section and another in the Munson Road / Farm Road area in the southwest section of town. A third expansion for the "Village" section of town (roughly, east of Newark Pompton Turnpike to Rt. 23, from Jackson Avenue south to Alexander Avenue) is currently in the planning stage.

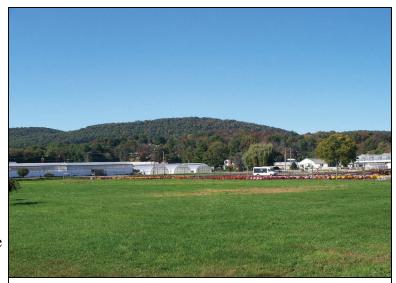
Figure 6-1: Vista from Jacksonville Road shows the dramatic change in Pequannock from the Piedmont region (foreground) to Highlands region (background).

As described in the section on Geology, Pequannock Township sits at the juncture of two geologic provinces in New Jersey: the flat/rolling Piedmont and the steep/rocky Highlands. Although the largest portion of Pequannock Township lies in the Piedmont and is very flat, having elevations that vary between 180 and 200 feet above mean sea level, in the northwestern corner that marks the beginning of the Highlands, a dramatic change in elevation occurs. In this area, which begins in the vicinity of the western portion of Mountain Avenue and the eastern edge of Mountainside Park, and is crossed by Route 287, elevations begin at about 200 feet and climb as high as 734 feet at the top of Pequannock's Turkey Mountain, aka Pequannock Knob (see Figure 6-2 and 6-3). Figure 6-1 shows the dramatic visual change in topography.

The abrupt change in elevation provides excellent views of Pequannock Valley from Mountainside Park. One can also view the mountains from several locations within the Township. Examples are at Jacksonville Road (see Figure 6.1), Chilton Hospital, and Route 23, when traveling north. Some of the pristine quality of these mountain views was lost,

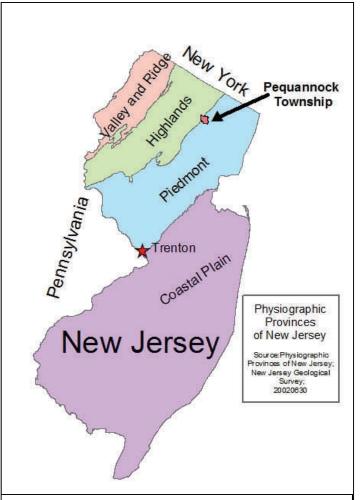
Figure 7-1: Physiographic Provinces Of New Jersey

former is a suite of sediments and volcanic rocks, approximately two hundred million years old, collectively referred to as the Brunswick formation, and the latter is crystalline plutonic and metamorphic rocks about one billion years old, known as the Precambrian formation. Only 18,000 years ago, both of these provinces were covered by the last glacial advance. Figure 7-1 illustrates the location of Pequannock in relation to these physiographic provinces, and Figure 7-2 shows the underlying geology of the township.

In Pequannock, the border separating the Highlands and Piedmont Provinces is the Ramapo Fault. The oldest rocks are Precambrian gneisses and plutonic zones that resulted from the metamorphism and melting, in place, of even older marine volcanics and sediments on the border of the ancient continental shield or craton of North America. These oceanic rocks were subducted to a depth of some 18 km., 600 to 700 degrees Celsius, and pressures of 5 kilobars (75,000 pounds per square inch). At this

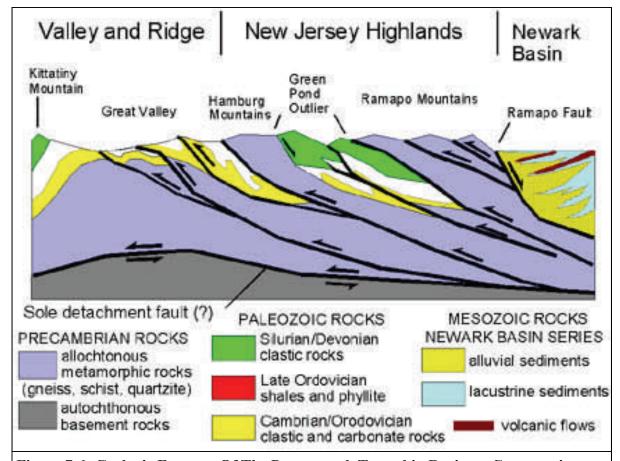
**Figure 7-6: Geologic Features Of The Pequannock Township Region—Cross section** Source: US Geological Survey, Highlands Sites in New Jersey, <a href="http://3dparks.wr.usgs.gov/nyc/highlands/ramapo.htm">http://3dparks.wr.usgs.gov/nyc/highlands/ramapo.htm</a>, 2003

depth, about 1.1 to 1.3 billion years ago, the oceanic sediments and volcanics were metamorphosed and locally melted to create the gneisses, marbles, pink granites and amphibolites we see today. They have been uplifted by plate tectonics and thrust faulting to where we see them in outcrops along Routes 23 and 287. This geologic upheaval formed the New Jersey Highlands Province, which is known as a source for the magnetite iron ores so vital during the Revolution and also as an apparent source of radon gas. These features are depicted in Figure 7-5 and Figure 7-6.

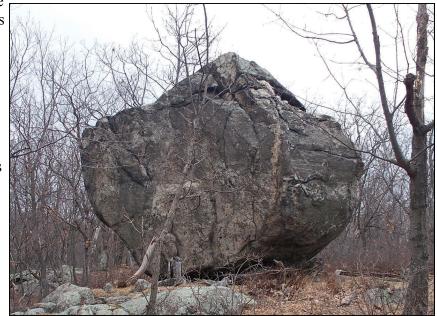
Figure 7-9: Boulder Deposited By Glacier, Mountainside Park

moraines, dumped in place as the ice receded, whereas the latter were carried and sorted by the meltwater streams. In Pequannock, pockets of till can still be found, with giant boulders on top of the peaks of the Highlands (see Figure 7-9). The valley, however, is mostly filled with fluvoglacial deposits dropped by torrential meltwater streams and moraine-dammed Glacial Lake Passaic sediments. As the ice thinned, holes or wells formed and the streams traversing the surface of the glacier deposited striated and

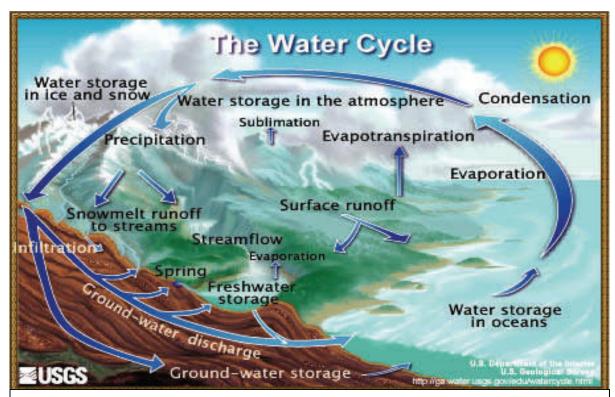
Figure 10-1: The Water Cycle

The source of all water on our planet is precipitation. In general, precipitation which falls to earth evaporates or transpirates into the atmosphere, infiltrates into the ground, or becomes surface runoff. The hydrologic cycle shown in Figure 10-1 illustrates this

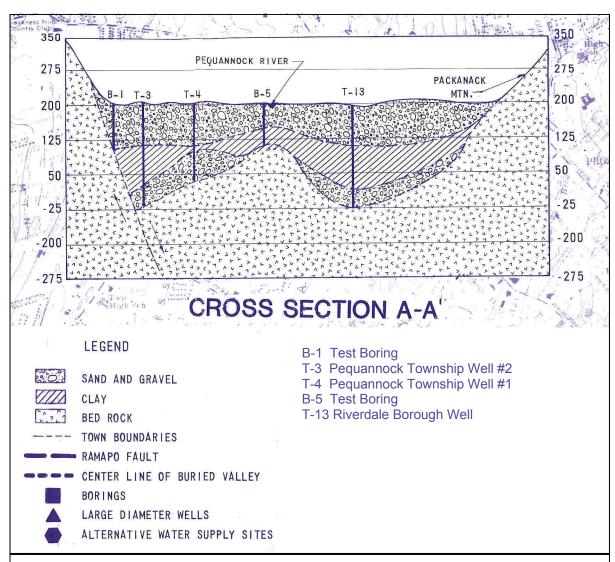
Figure 10-12: Map Reproduced From "Ground-Water Supply Survey for Township of Pequannock New Jersey" By Malcolm Pirnie, Inc., July, 1980

In 1980, Pequannock contracted an engineering firm, Malcolm Pirnie Inc., to conduct an investigation into the nature and extent of the aquifer recharge areas in the township. The aquifer, which underlies the water table, supplies the water for the township wells. This study produced a map that delineated the aquifer recharge area (see Figure 10-13). Two different recharge areas are shown on the map based on two different approaches. These

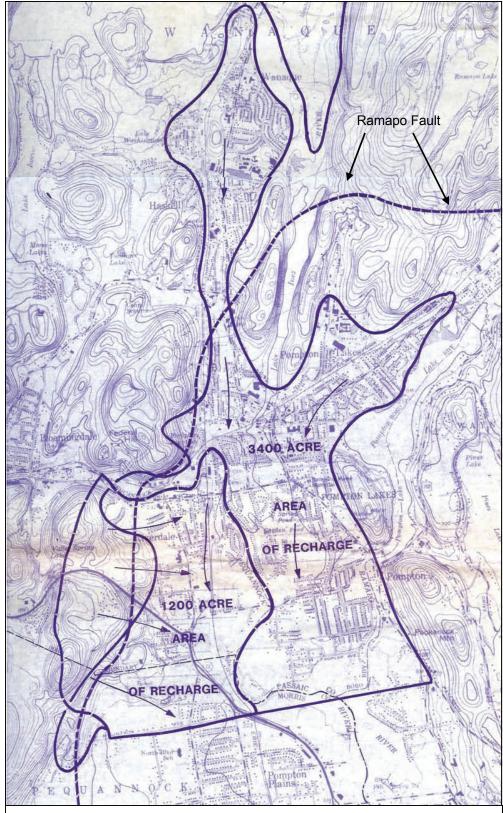
Figure 10-13: Recharge Areas And Groundwater Flow Plan, Malcolm Pirnie, Inc. 1980

As shown in this Figure, the highest recharge rates are found along the Ramapo Fault, close to Rt. 287. Although not all the areas having higher levels of recharge are located in places important to Pequannock's public water supply, they do help to maintain local stream and river flows during low-rainfall periods, as well as preventing excessive runoff and flooding during storm events. Therefore, areas with higher recharge potential should be recognized and protected.

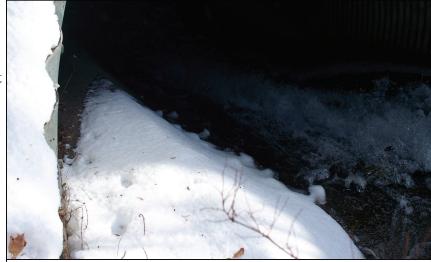
Figure 11-11: Tracks Of Eastern Coyote Entering Stream Culvert Beneath Rt. 287 Near Mountainside Park.

feeding sign is persistent on the Pequannock River (see Figure 11-10) but other signs of habitation, such as lodges or dams have not been documented. For now, beavers seem to be occasional visitors to the Township. Mink and muskrat are less demanding in their requirements and make use of almost all of Pequannock's waterways and wetlands. Although important to aquatic animals, riparian corridors also provide travel routes for terrestrial animals. Figure 11-11 shows the use of a stream culvert by a coyote traveling under Route 287.

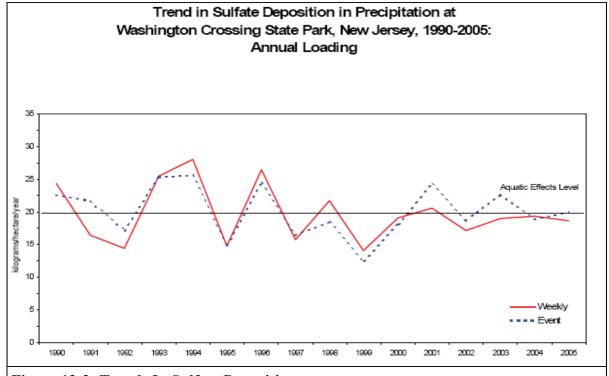
Sulfate can alter soil and water chemistry, and a deposition level of 20 kilograms per hectare per year has been generally accepted as the limit above which damage to sensitive natural resources is likely to occur (i.e. Aquatic Effect Level). However, there are no national or New Jersey standards for sulfate deposition.

**Figure 12-2: Trends In Sulfate Deposition** (Source: NJDEP, 2001 Atmospheric Deposition Summary, <a href="http://www.state.nj.us/dep/airmon/depo01.pdf">http://www.state.nj.us/dep/airmon/depo01.pdf</a>)

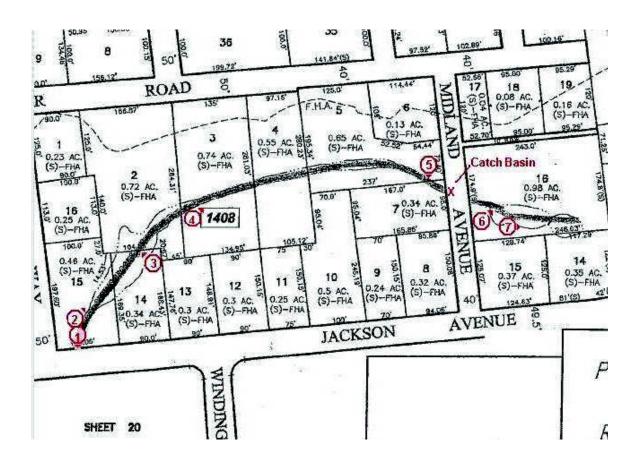
Highlight #1: (Photo 08) Pond East of Midland Ave, at small dam (upper pond appears to be concrete lined).

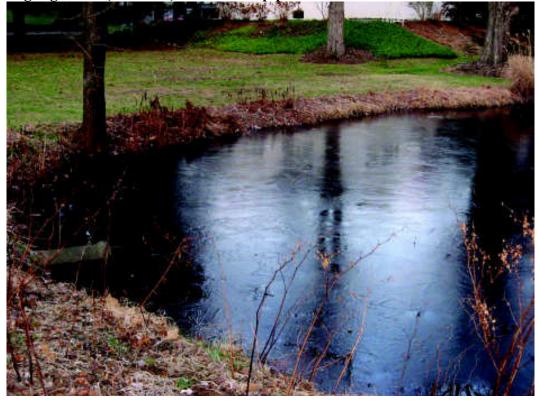
Highlight #3: (Photo 06) Spring Brook, West Side of Midland Ave.

(Looking south at location of outlet of pipe crossing under Midland Avenue. Outlet not visible, may be obstructed with soil, leaves and sticks; slow flow is evident at pictured location. Location of catch basin on Midland Ave may mark pipe crossing location.)

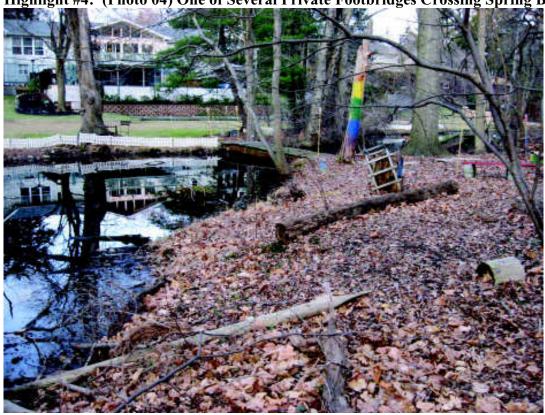
Highlight #5: (Photo 02) View of Spring Brook Looking North From Jackson Ave.

- 01 Looking downstream (south) through culvert under Jackson Ave. Clear except for possible obstruction at far end.
- 02 Looking upstream (north/northeast) toward island and bend. Some trash along sidewalk in brush and in brook.

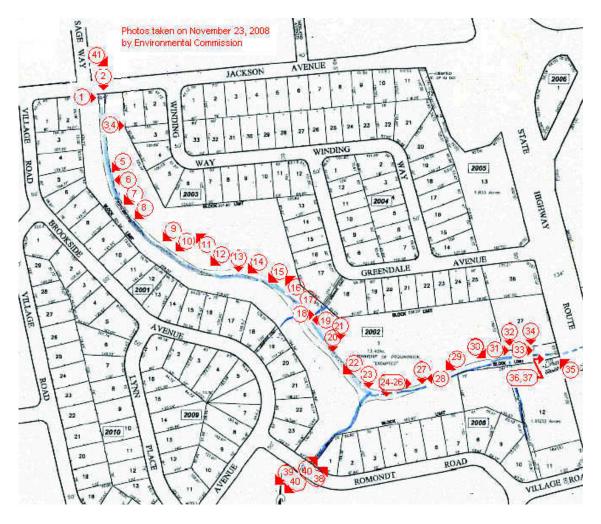
Highlight #1: (Photo 001) Typical view of Spring Brook (from Jackson Ave Bridge)

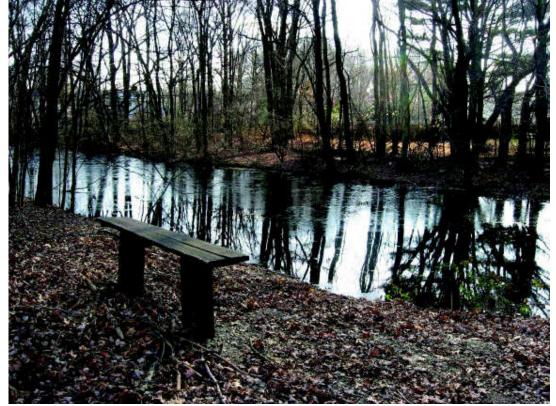
Highlight #2: (Photo 021) Spring Brook, just downstream of Greendale Ave Ditch

- 020 looking downstream from bench (see photo 021)
- 021 bench (opposite Block 2001 Lot 20)
- 022 looking east up right of way between Block 2001 Lot 23 and Block 2008 Lot 1. Looks swampy from this distance.

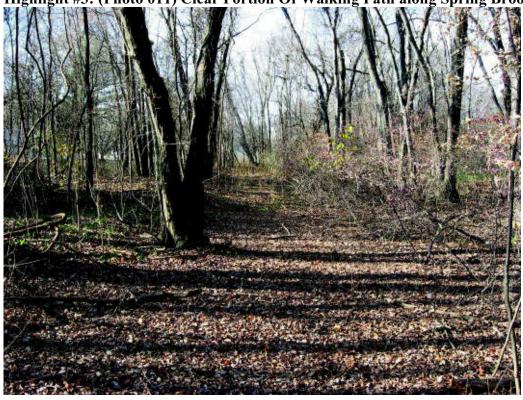
Highlight #3: (Photo 011) Clear Portion Of Walking Path along Spring Brook

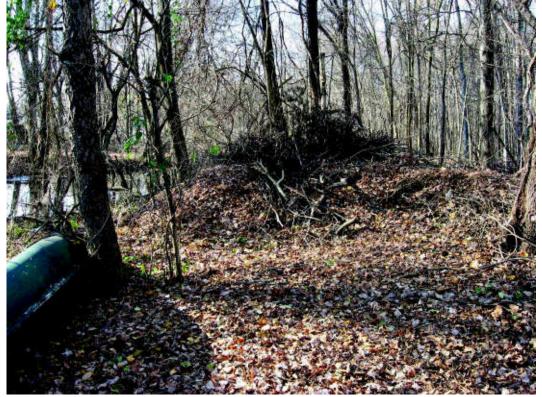
Highlight #4: (Photo 016) Yard Waste Debris Pile along Path beside Spring Brook

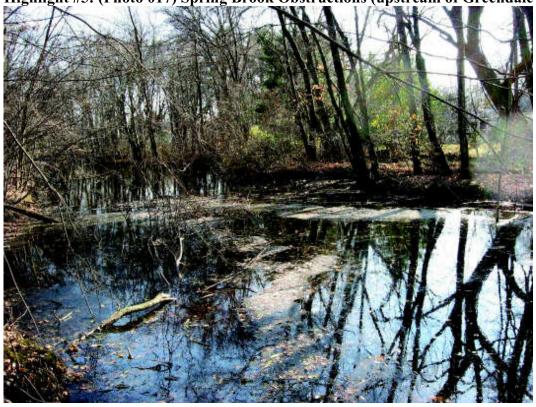
Highlight #5: (Photo 017) Spring Brook Obstructions (upstream of Greendale Ditch)

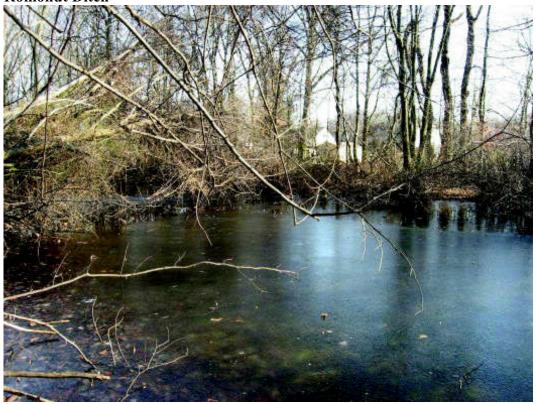
Highlight #6: (Photo 025) Shrubs & Trees in Spring Brook, just downstream of Romondt Ditch

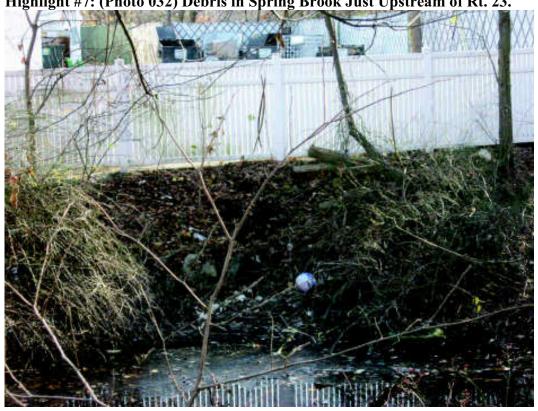
Highlight #7: (Photo 032) Debris in Spring Brook Just Upstream of Rt. 23.

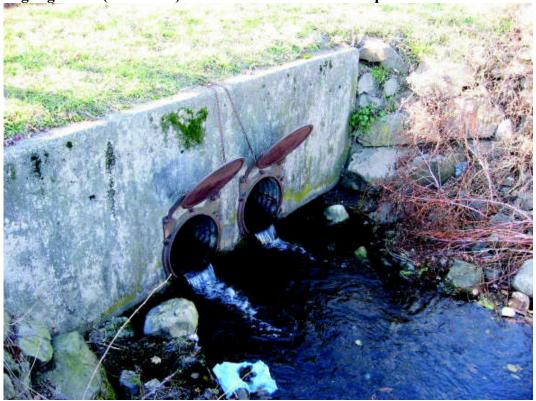
Highlight #9: (Photo 035) Backflow Preventers Just Upstream of Rt. 23 Culvert

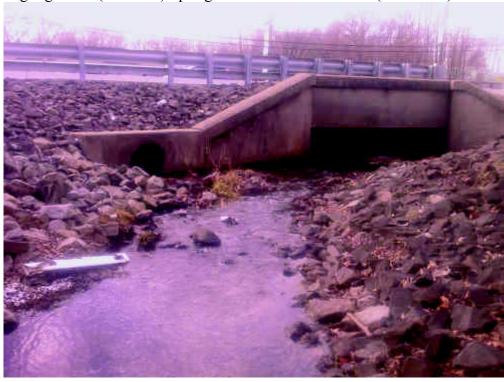
Highlight #1: (Photo 01) Spring Brook Culvert At Rt. 23 (Note trash)

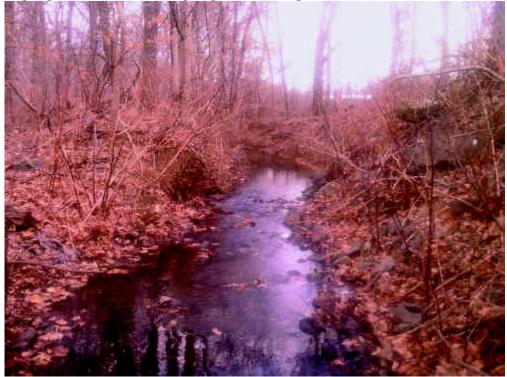
Highlight #2: (Photo 02) Spring Brook, Steep Banks

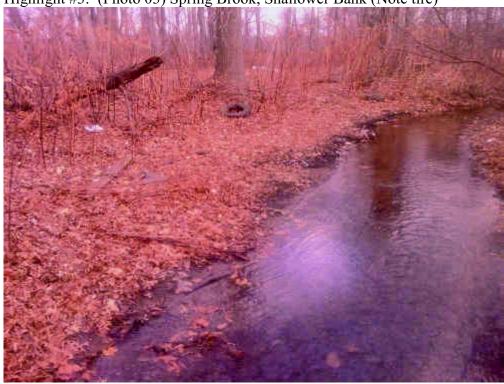
Highlight #3: (Photo 03) Spring Brook, Shallower Bank (Note tire)

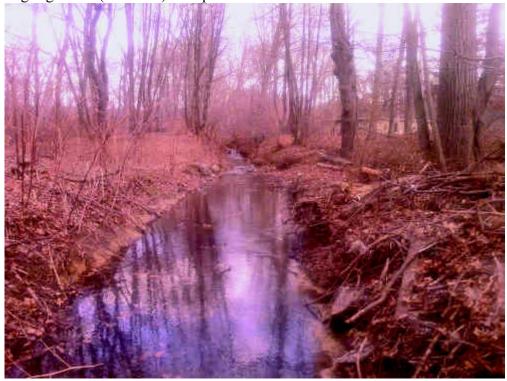
Highlight #4: (Photo 04) Steeper Banks With Debris

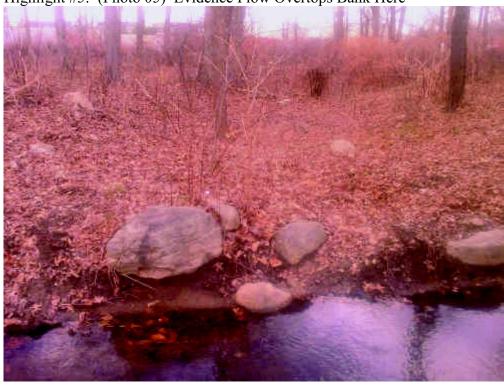
Highlight #5: (Photo 05) Evidence Flow Overtops Bank Here

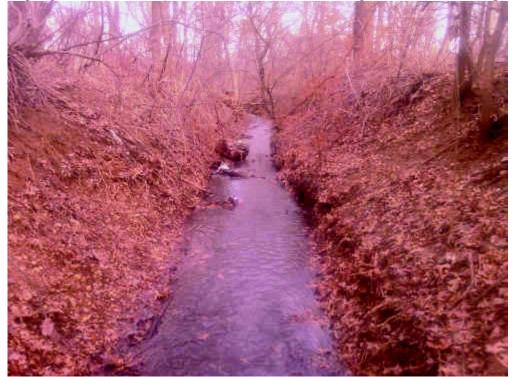
Highlight #6: (Photo 06) Narrow Stream Bed with High Banks (Note stump)

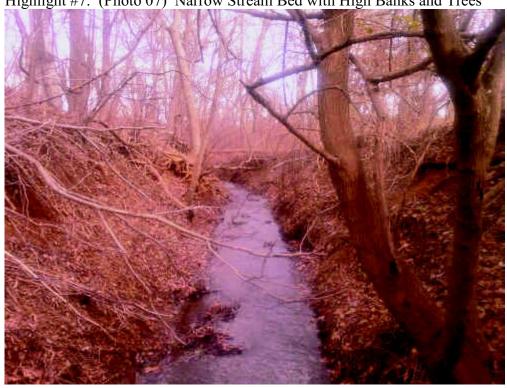
Highlight #7: (Photo 07) Narrow Stream Bed with High Banks and Trees

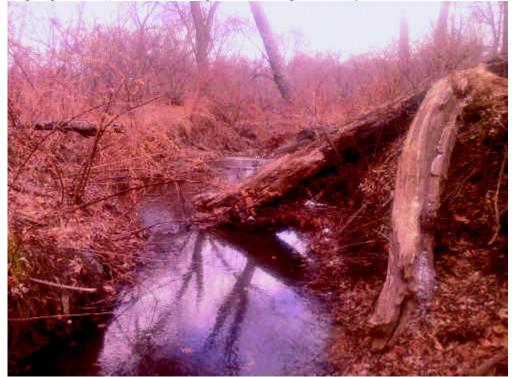
Highlight #8: (Photo 08) Large Tree Stumps Partially In Stream

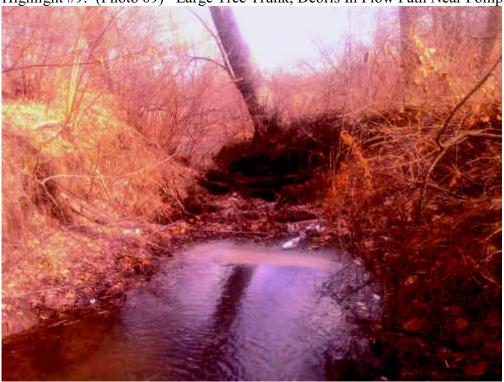
Highlight #9: (Photo 09) Large Tree Trunk, Debris In Flow Path Near Pompton River

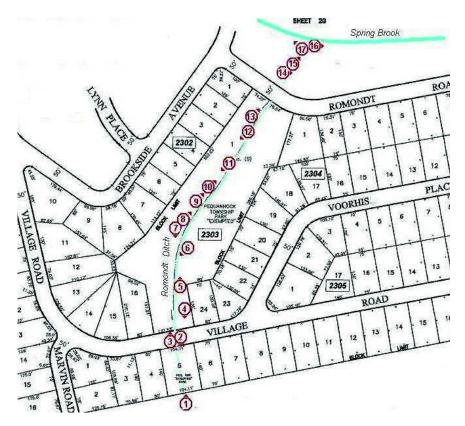
Highlight #1 (Photo 01) Romondt Ditch at South End (Village Road / Meyer's Brook)

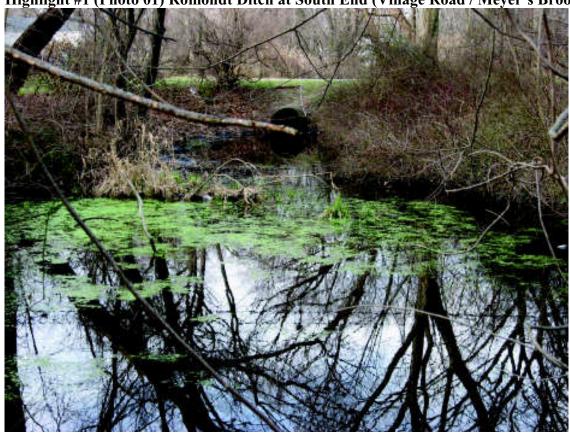
- 01 From south of Village Road (Meyer's Brook), looking north toward Village Road culvert. Note large dead tree on west side of stream leaning against another tree. If this tree falls, there will be an obstruction. (also see next photo)

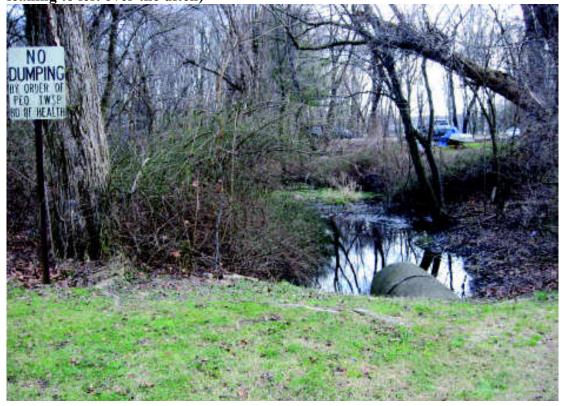
Highlight #2: (Photo 02) Romondt Ditch South from Village Road (note dead tree leaning to left over the ditch)

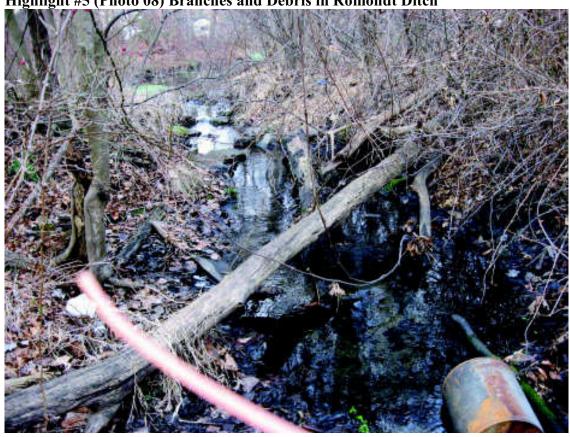
There is a large tree and several large branches across the main channel of flow. These may cause flow to back up locally several feet upstream (north) in higher flow conditions. It is recommended that these logs be cut and/or cleared.

Highlight #5 (Photo 08) Branches and Debris in Romondt Ditch

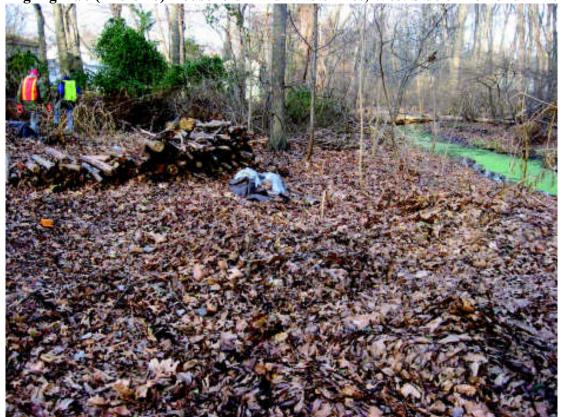
Litter levels were generally low, with higher concentrations of litter around Romondt Street. Debris including litter as well as vegetative yard waste was also observed along the rear of the homes along the western side of the ditch.

Highlight #6 (Photo 10) Household Yard Waste Piles, West Side of Romondt Ditch

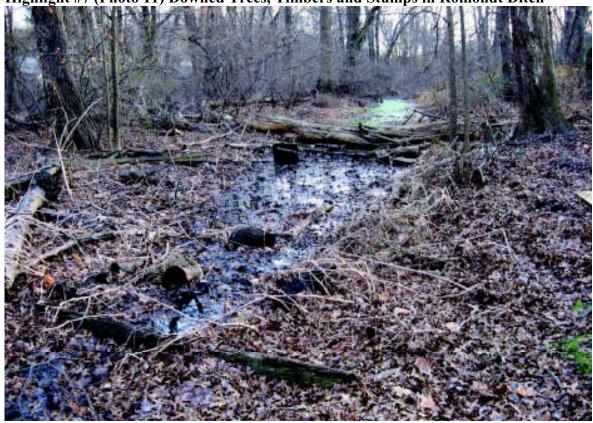
Highlight #7 (Photo 11) Downed Trees, Timbers and Stumps in Romondt Ditch

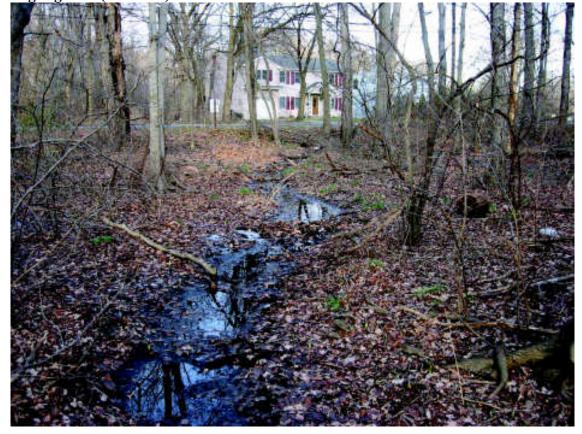
Highlight #8 (Photo 13) Romondt Ditch Just South of Romondt Ave

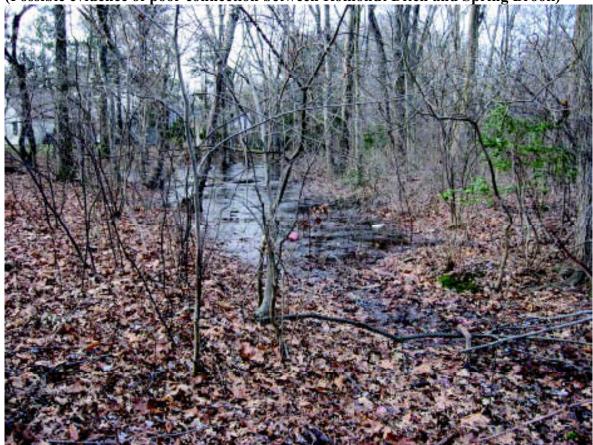
Highlight #9 (Photo 17) Standing Water Between Romondt Ditch and Spring Brook (Possible evidence of poor connection between Romondt Ditch and Spring Brook)

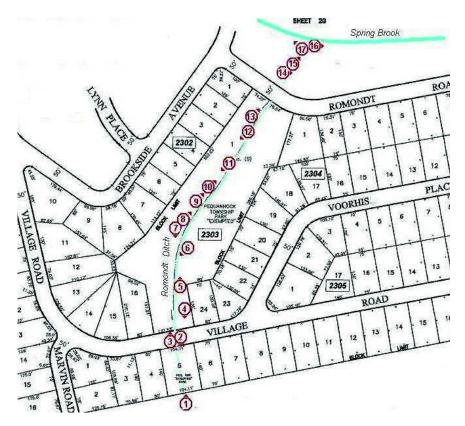
Highlight #1 (Photo 01) Romondt Ditch at South End (Village Road / Meyer's Brook)

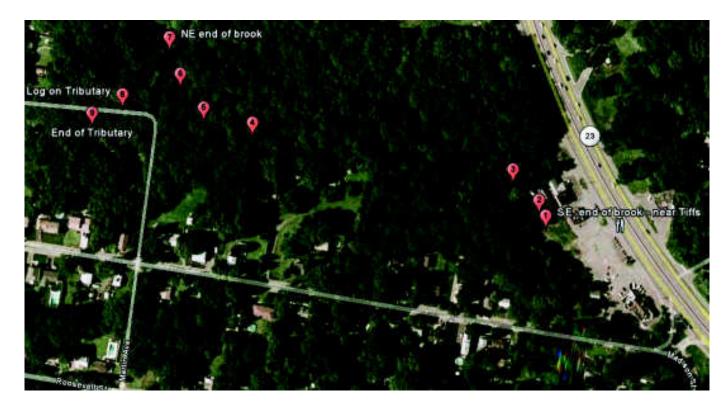
Photo #1 -- N40° 57' 09.04" W074° 16' 49.3" Southeast end of brook (near Tiffs), view looking south (toward Tiffs parking lot.

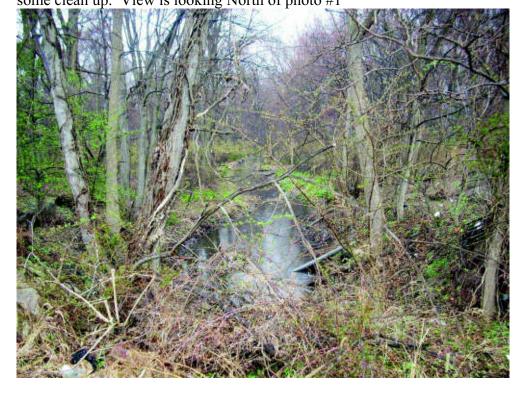
Photo #2 -- N40° 57' 09.5" W074° 16' 49.6" Southeast end of brook (near Tiffs). Needs some clean up. View is looking North of photo #1

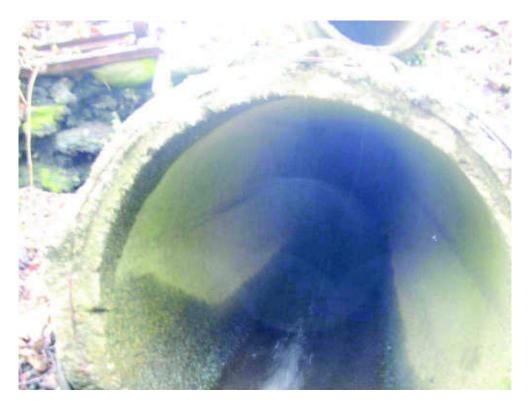
Photo #3 -- N40° 57' 10.4" W074° 16' 50.7" View from West bank of brook.

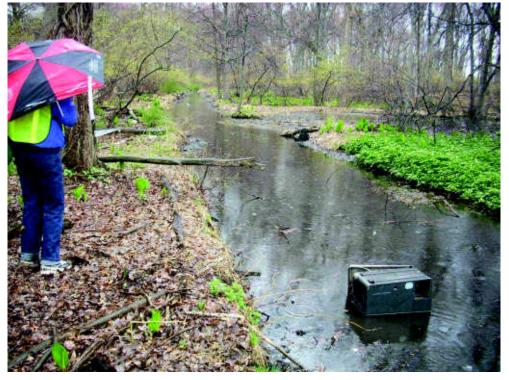
Photo #4 -- N40° 57' 11.5" W074° 17' 01.3". Object should be removed. View from South to North.

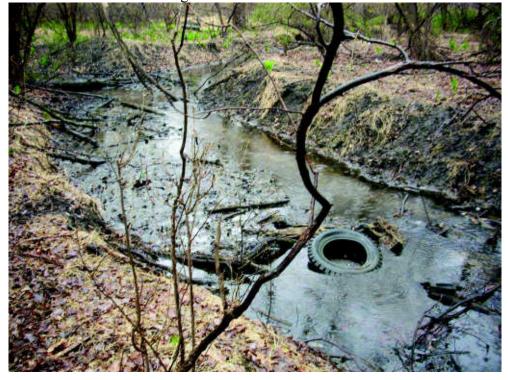
Photo #6 -- N40° 57' 12.9" W074° 17' 04.3". More debris to be removed. View from West bank of brook looking North.

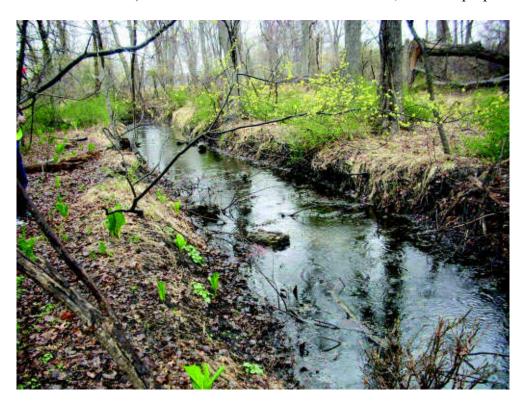
Photo #7 -- N40° 57' 14.0" W074° 17' 04.8" Northeast end of brook (adjacent to McDonalds Beach). Trees have to be removed from brook, to insure proper flow.

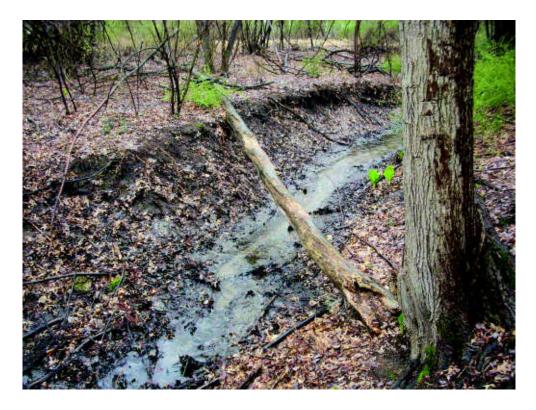
Photo #8 -- N40° 57' 12.2" W074° 17' 06.6" Log on tributary.

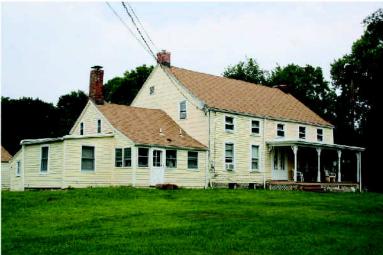
**Picture**

Fenestration: 1/1 double-hung sash replacement windows. Two primary entrances - one double-leaf in the main block and one

integrity, it is not known to be a significant example of its method of construction, nor is it known to be the work of a master (Criterion C). There is also no evidence that this building will be able to provide information important in history or prehistory (Criterion D). Research has not suggested a connection between this house and significant individuals (Criterion B). No historic information has been found to suggest that the building was associated with significant events in the history of the Pequannock area (Criterion A). The building is not

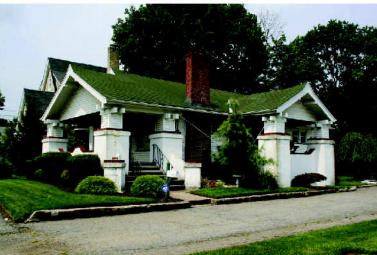
**Picture**

Exterior Wall Fabric:	Aluminum siding
Roof / Chimney(s):	Cross gable roof clad in asphalt shingles with swept gable apex; 1 exterior brick chimney
Fenestration:	Multi-light-over-single pane windows
Additional Architectural Description:	Oriental influences apparent here in the roof shape and porch posts. Blocky stuccoed porch piers topped by clusters of 4 wooden posts, which are now encased in aluminum siding.
History:	A number of Sears & Roebuck, and other catalogue-type houses, have been noted in Morris County. This building is an example of the "Osborn," one of the most distinctive bungalows marketed by Sears. This style was offered between 1916 and 1929. It is an example of mass production in housing, and illustrates World War I-era taste in domestic architecture. It includes such typical features as stucco cladding, with brick and stucco piers, and multi-light-over-one wood double-hung sash windows. Timber porch posts are currently obscured by aluminum siding.

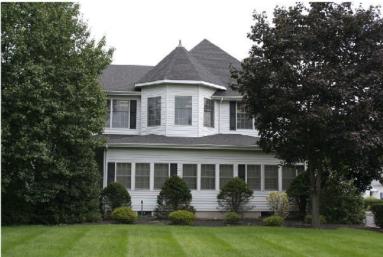
**Picture**

Additional Architectural Engaged semi-octagonal tower rises through porch roof. During a field visit in 2004, County staff noted that since the 1986 survey, the front porch has been enclosed, and vinyl siding and inoperable paneled shutters have been added. Furthermore, a 2-story, 2-bay segment had been added to the side, and a former arched window at the second story has been replaced by paired 1/1 double-hung sash windows. A 2006 site visit noted that additionally, the former slate roof has been replaced with asphalt shingles, and the chimney has been stuccoed.

This building is an example of the Queen Anne style; however, alterations have greatly affected its overall integrity. It is not a significant example of its style, type, period, or method of construction, nor is it known to be the work of a master (Criterion C). There is also no evidence that this building will be able to provide information important in history or prehistory (Criterion D). Research has not suggested a connection between this house and significant individuals (Criterion B). No historic information has been found to suggest that the building was associated with significant events in the history of the Pequannock area (Criterion A). The building is not eligible for the National Register.

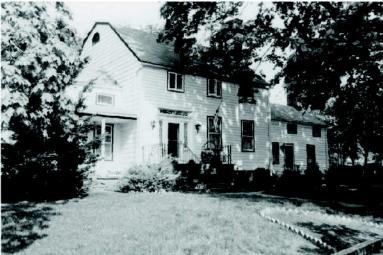
**Picture**

Additional Architectural Main block is 3-bay side hall plan with oversized entry consisting of broken entablature paneled pilasters and leaded transom and side lights, all set within molded architrave with corner blocks. Flanking wings have been

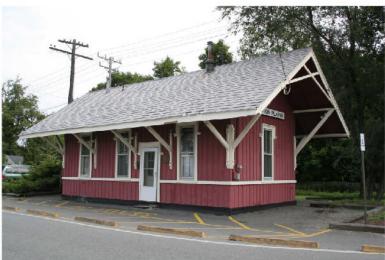
**Picture**

Board and batten
Slate-clad side gable roof with deep overhanging eaves
Wood 2/2 double-hung sash windows with metal storms
The distinguishing feature of this small station is its huge chamfered stick brackets. Decorative detailing includes simple wooden stringcourse below the windows and a water table. The track side elevation includes a bay window. The door on the west side is a modern replacement.
See information contained in the National Register nomination for this property.
Only a few late 19th-century stations survive in Morris County to illustrate the character of rail facilities before the enormous expansion of the early 20th century. According to the NR Nomination, this station is "a fine example of early railroad architecture with Carpenter Gothic features and unusual 'Dutch Cap' wooden hood moldings over the doors and windows." The NJ HPO has stated that the station "is significant because of its association with the 19th century Pompton Plains community as a rare surviving remnant of the Montclair and Greenwood Lake Railway and its successors. It is also architecturally significant as an noteworthy (sic) example of the application of the Stick style to a small public transportation building"

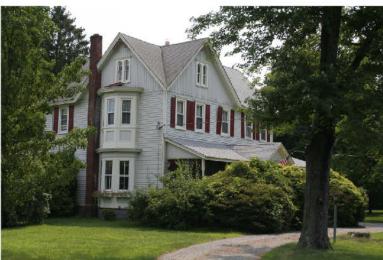
**Picture**

Fenestration: 2/2 wood double-hung sash windows; 1/1 vinyl double-hung sash replacement windows with snap-in dividers.

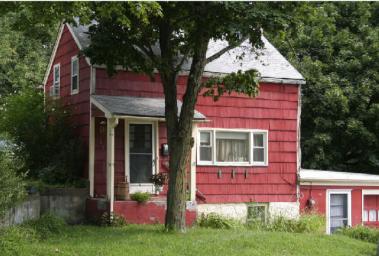
Map Location **Picture**

Exterior Wall Fabric:	Asbestos siding
Roof / Chimney(s):	Side gable roof with flush eaves; 1 interior gable-end chimney
Fenestration:	Modern 1/1 vinyl replacement windows and 2/2 wood double-hung sash in the side gable end; 1/1 vinyl window at basement level.
Additional Architectural Description:	Addition to side has single leaf pedestrian entrance with 2-paneled door, and a wood paneled pull down garage door; shed roof portico with concrete stoop at primary entrance supported by 2 wood posts.
Histor <b>y</b> :	Reference to the map sequence is inconclusive in this case. The 1853 map notes the existence of a "Stillery" at this approximate local, but the 1868 map places the "Distillery" on the opposite side of the road and depicts nothing where the house stands.
Significance:	This is an example of an East Jersey cottage-style dwelling. Alterations, including the replacement of windows, and additions, including a low, flat roofed garage at the side, have altered its form and reduced its integrity so that it no longer reflects its original construction (Criterion C). Little historic information has been found for this property, and it is not known to be associated with significant events or people in the history of Pequannock, the state, or the nation (Criteria A and B). This house is not likely to be able to provide information important to history or prehistory (Criterion D). It is not eligible for the National Register.

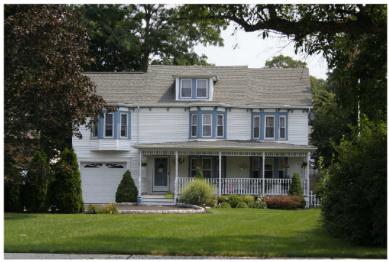
**Picture**

Additional Architectural Simple block has been altered with polygonal façade bays and a 1-story open porch with replacement turned posts, balustrade, and spindlework. Entire right side is recent addition, according to owner in 1986. Paired Italianate brackets at main roof cornice. Two-story addition at left contains one-car garage on first floor.
